UPPER WHARFEDALE HERITAGE GROUP

THE UWHG KILNSEY PROJECT 2015 - 2020

BUILDING REPORT FOR: KB 08

CRAG COTTAGE– KILNSEY

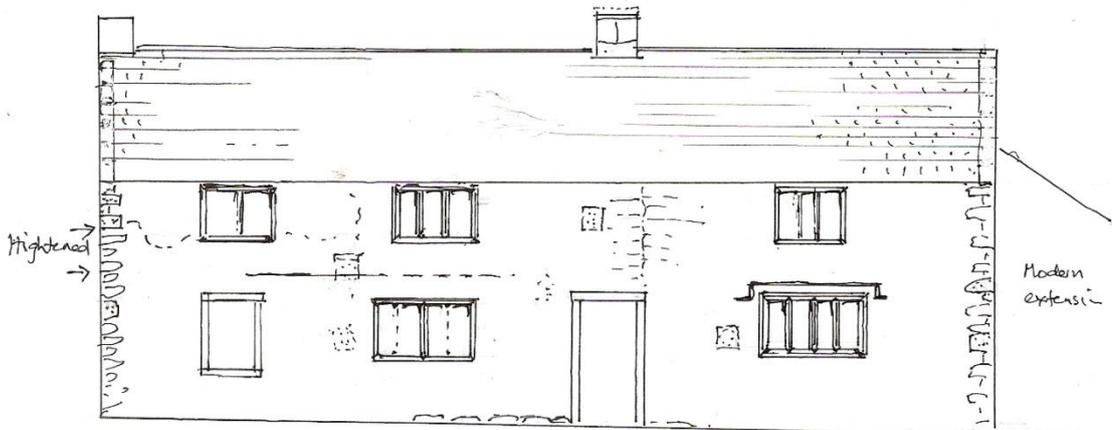
SOUTH FRONTAGE

Frontage (see drawing) has mullioned 17thC windows but the front door surrounds are 19thC and of simple, squared sandstone. There are some small blocked-up windows, possibly fire or stair windows. There are other disturbances such as a slight ledge at first floor level that may represent a former roofline or a rebuild and straight joints running down the wall.

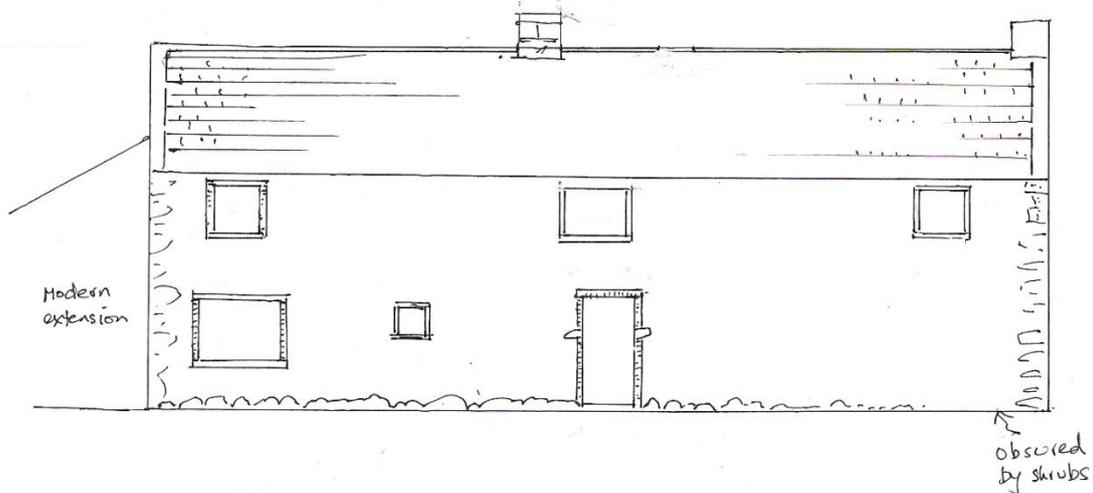
NORTH, REAR ELEVATION

The rear elevation (see drawing) displays boulder foundations, exposed after soil was cleared to make a flat garden patio area. Boulder foundations are usually associated with buildings of pre 1600 date. The window and door surrounds are all 19/20thC stone with some c1800, re-used, with Georgian broad-tooling.

All windows and door look modern,
though some of re-used stone c.1800.

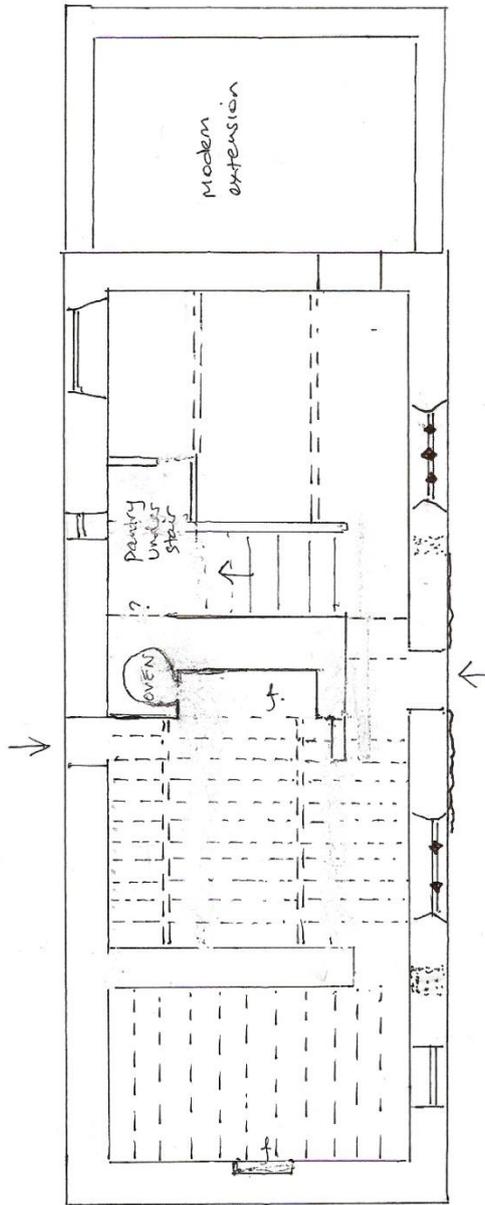
PLAN

The house is of three bays, with the west bay possibly added. It has a lobby entry beside the chimney stack. The 19thC main doorway is probably a replacement of a 17thC one, in which case the house would have had a classic 17thC lobby entry. On the left, the lobby opens into the housebody (the living room). The parlour (best room) is on the right with the best window. Its fireplace may have backed onto the housebody fireplace and the stack, before the stair was moved to its present position.

The housebody has a large arched fireplace with beehive oven.
This room and the adjoining end room (dairy/service room?)
have close-set joists but they appear modern.
Roof trusses look like re-used medieval or 16c.

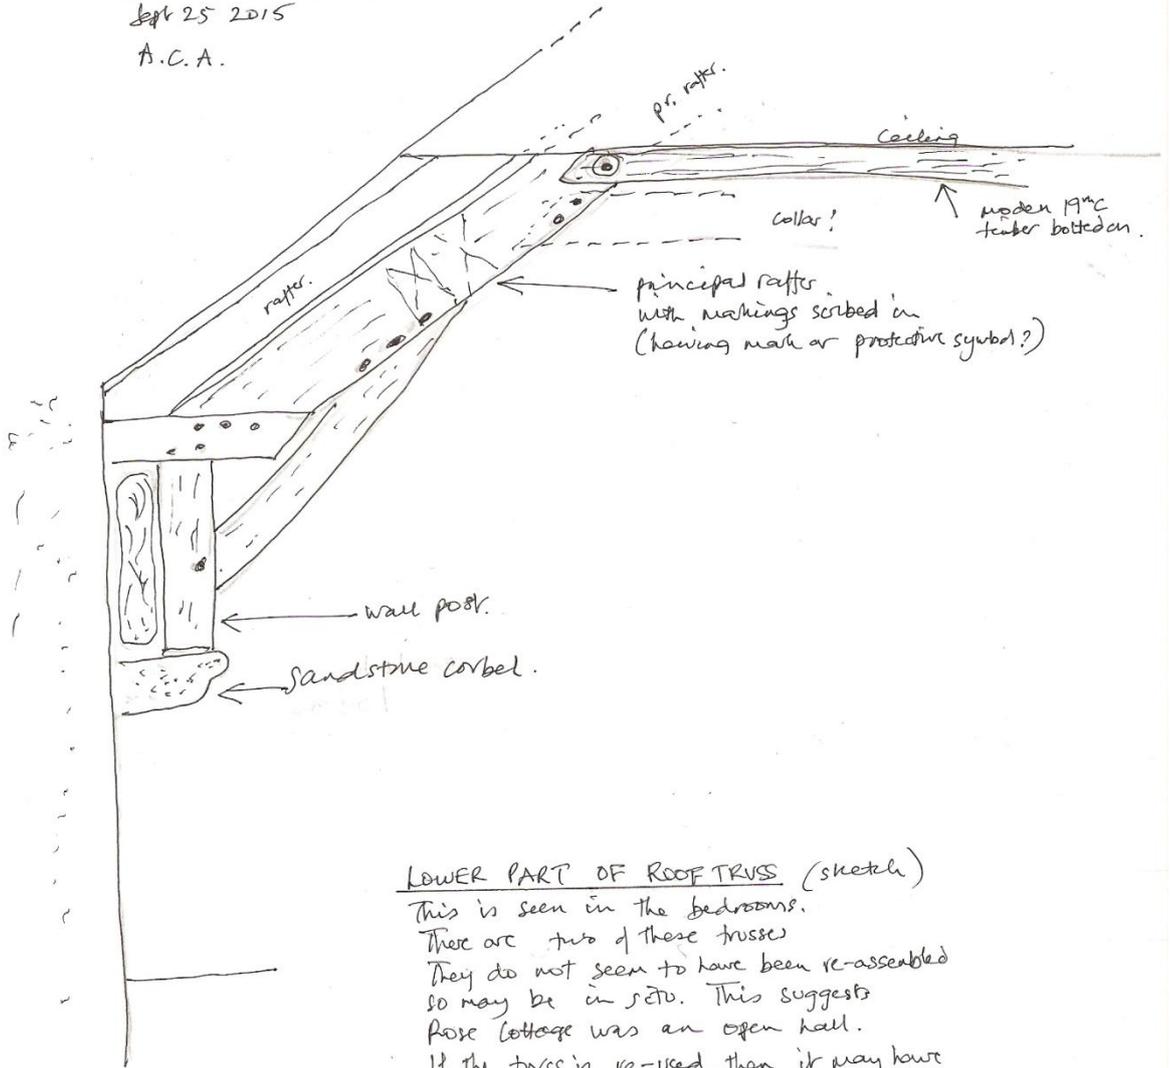
LOWER PART OF ROOF TRUSS (sketch)

There are two roof trusses - one over the housebody and one over the parlour. (See drawings) The trusses follow medieval practice in being supported by short wall posts standing on shaped stone corbels. The wall posts and bases of the principal rafters are both mortised into a short stub-tie which is braced into a timber pegged to the post and the principal rafter.

This is seen in the bedrooms.

There are two of these trusses

They do not seem to have been re-assembled so may be in situ. This suggests Rose Cottage was an open hall.

If the truss is re-used, then it may have come from the chapel building. This had 2 stone corbels for two trusses in it, when I looked some years ago. Or it could have come from the cowhouse in Kilnsey Old Hall as Wade was rebuilding it. Or it could have come from the gatehouse (making it 16th C rather than 17th C as I had thought?)

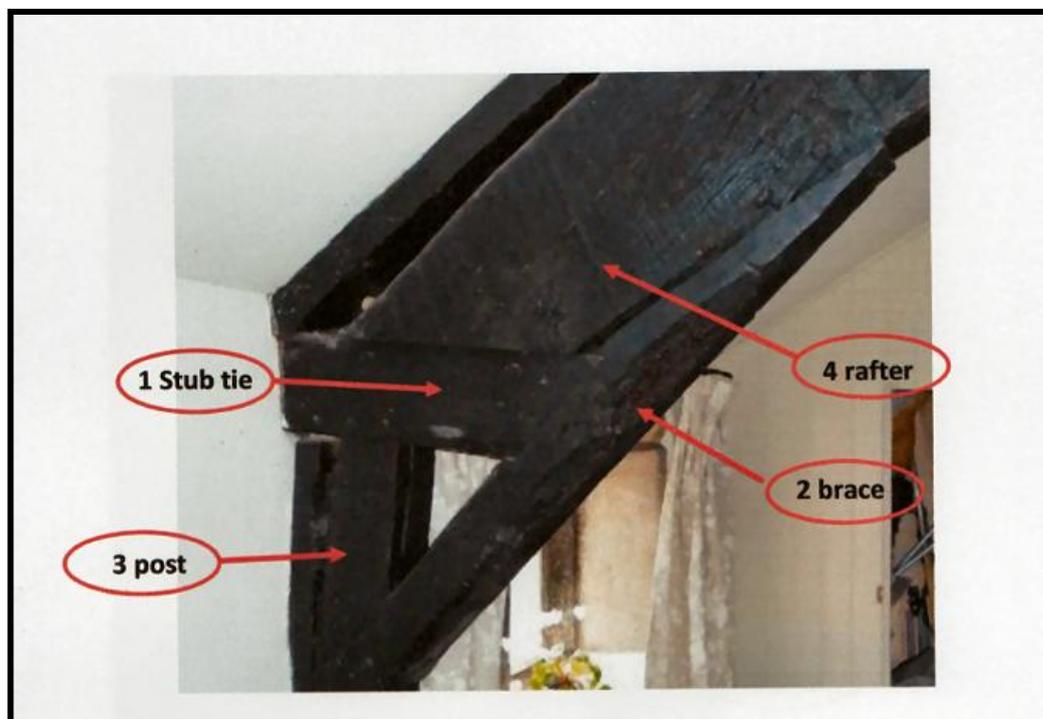
A section of the East Truss – with the components named

The rings of the stub tie measured from 1254 to 1370 with complete sapwood present therefore giving a felling date of 1370.

Although the wall-post had complete sapwood, the material was fragile and some was lost in coring. However the measured rings were from 1261 to 1349 with a similar boundary between the heartwood and sapwood to that of the stub tie, therefore the felling date for the wall-post is also about 1370.

The principle rafter had rings from 1164 to 1308 but no sapwood or even the heartwood boundary. However given the size of the timber and it's probable age of about 250 years when cut, the felling date is more likely than not, to be late fourteenth century, which makes it possible that this also dates to around 1370.

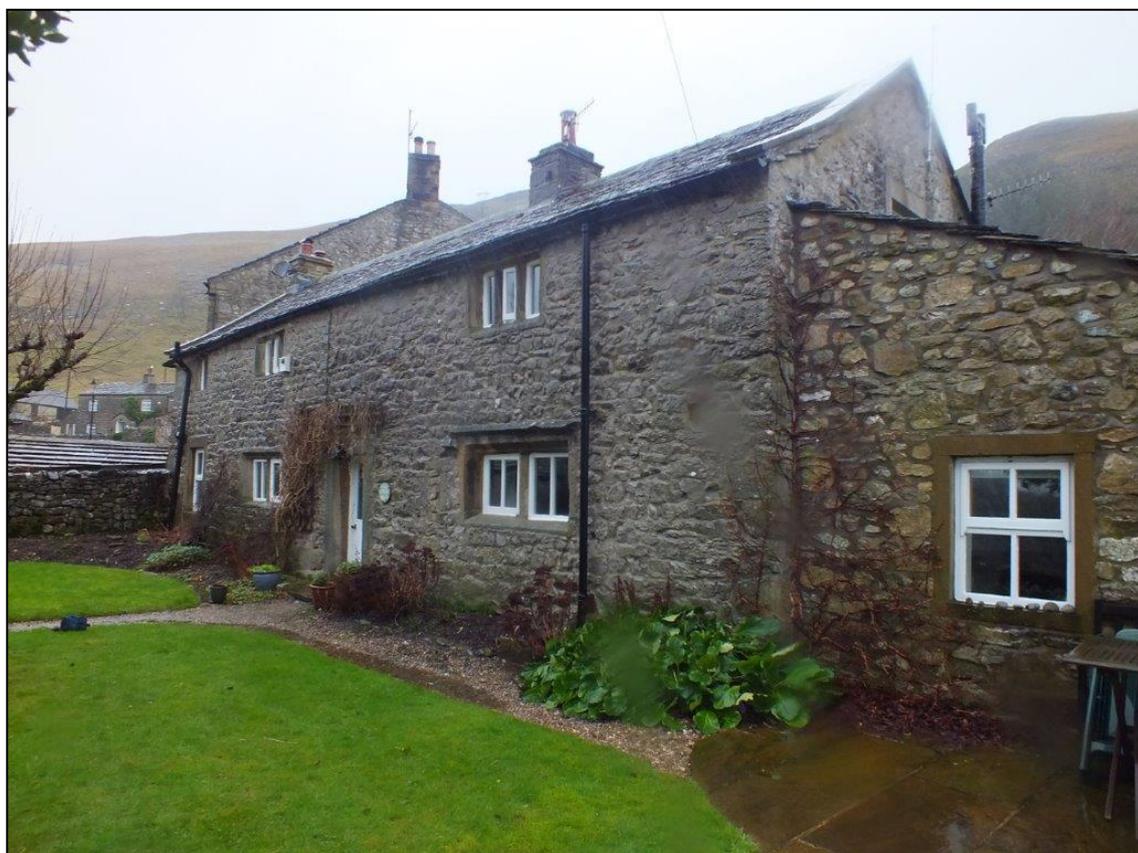
Image i/d KB 08 P01

South Elevation

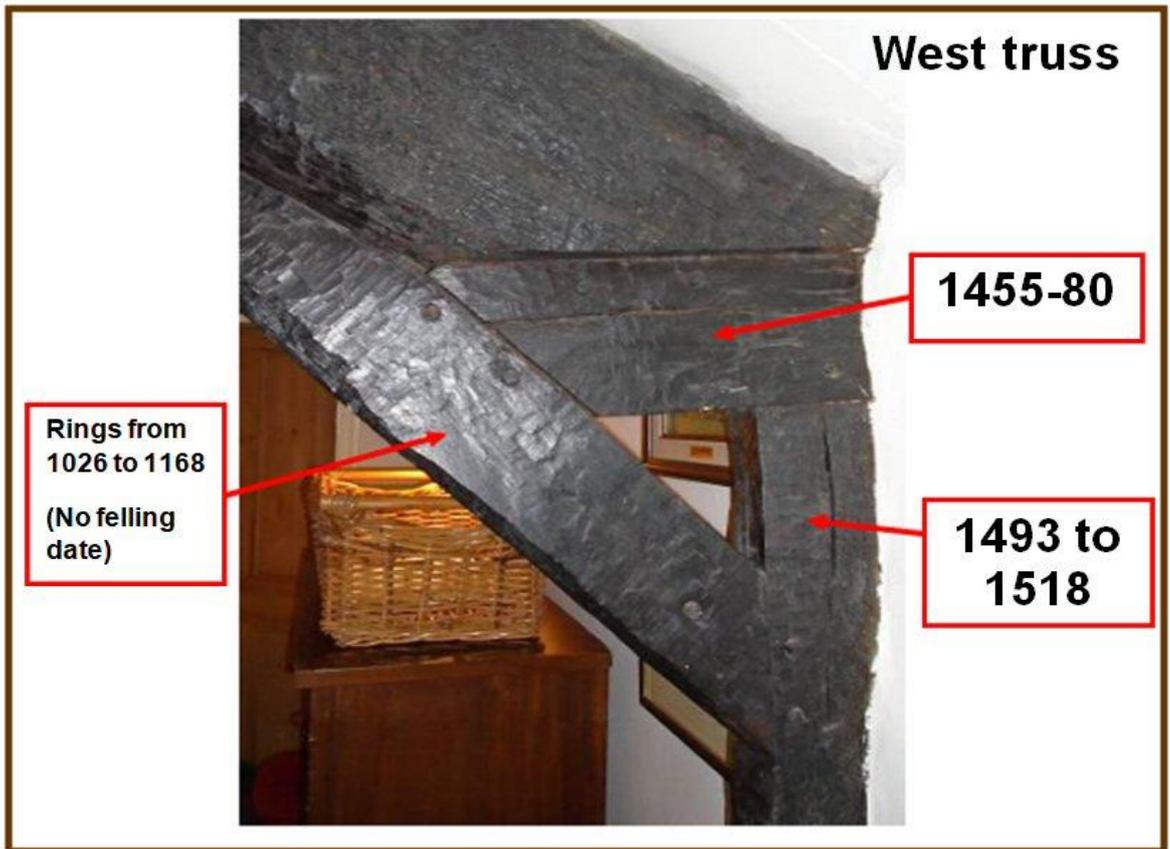
Image i/d KB 08 P03

It is striking how roughly the cottage roof was put together as if none of the builders were carpenters. This is particularly obvious in the west truss where the principal rafters appear to be posts from an earlier timber framed building with minimal re-shaping to fit the cottage roof. This reluctance to re-shape timbers suggests the components of this truss were inherited from an earlier roof, perhaps one giving dendro-dates of 1455-1480 or one likely to date from 1493-1518.

West Truss – North End

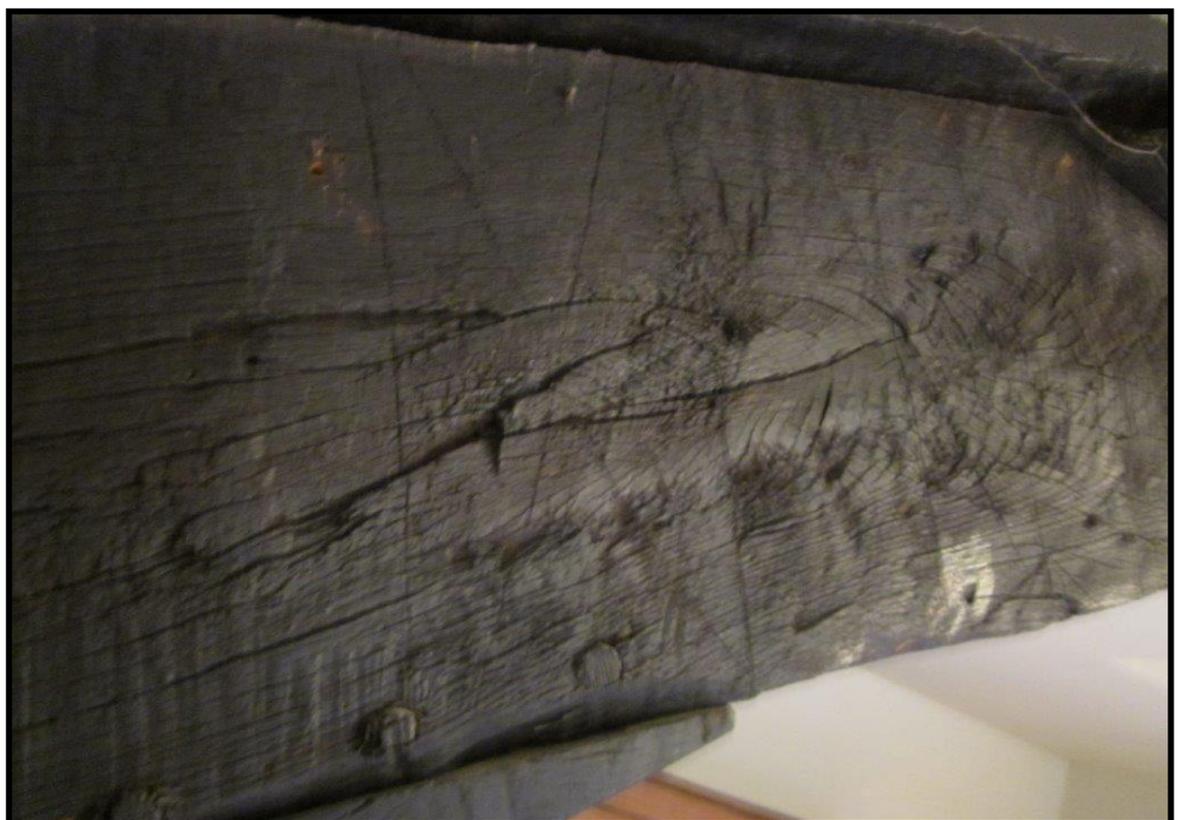
Image i/d KB 08 P04

On the timbers there are carpenters' scribed-on markings including a very large "butterfly" hewing mark.

Hewing Mark - East Truss

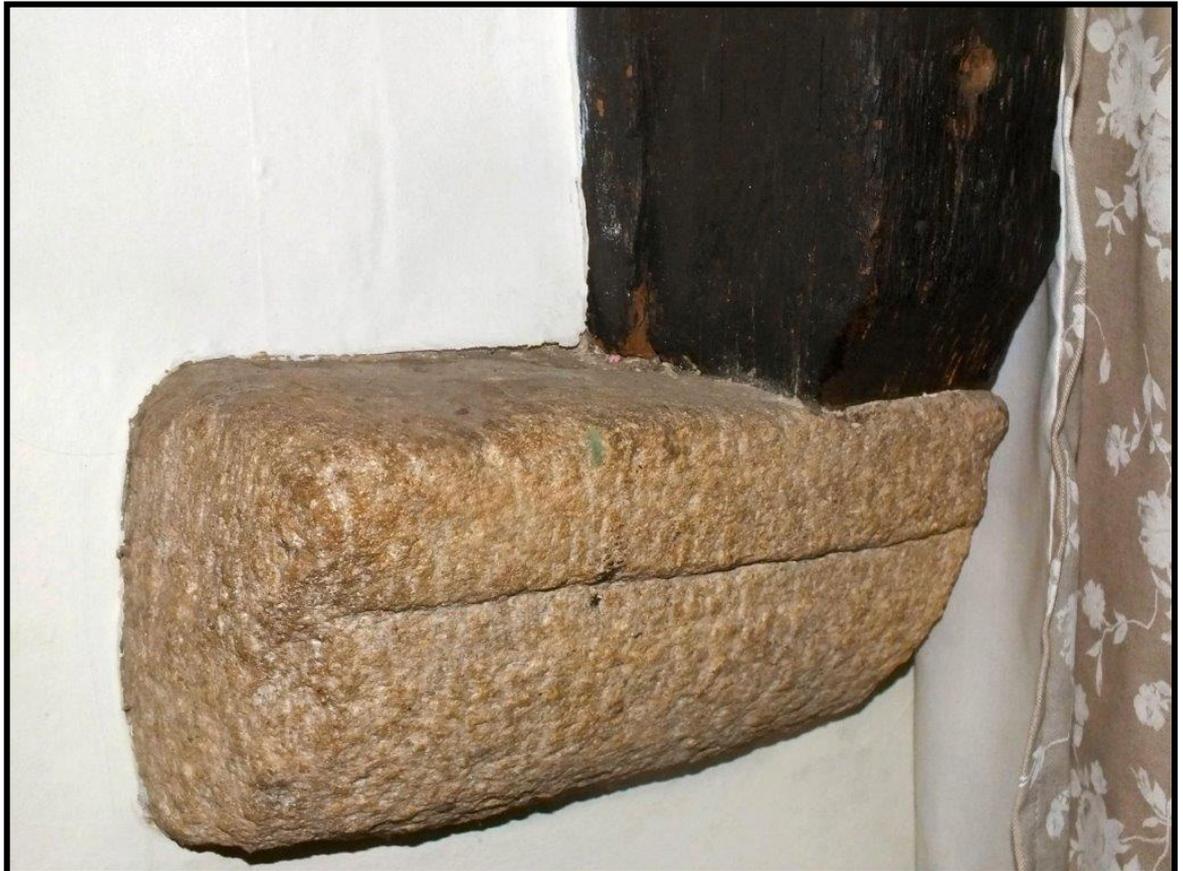
Image i/d KB 08 P05

Stone Corbel - East Truss

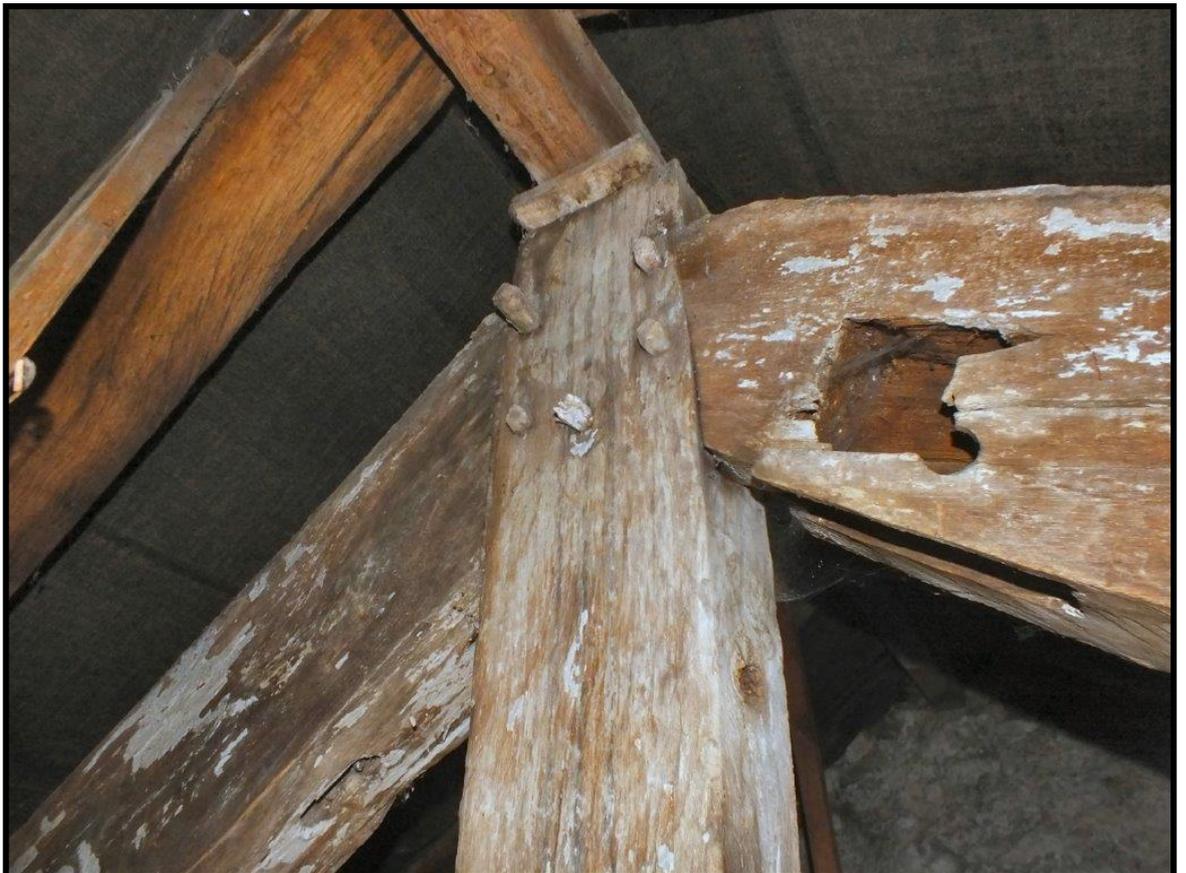
Image i/d KB 08 P06

The roof structure is composed almost entirely of re-used timbers, probably from a variety of other buildings. On the east truss (above the parlour) the upper king post and the south principal rafter, both have redundant mortices. The principal rafters of the west truss (above the housebody) end with the tenons leaning against an improvised upper king post. The south purlin at the west end of the building was identified as a re-used wall plate with close set rafter settings.

Upper King Post - East Truss

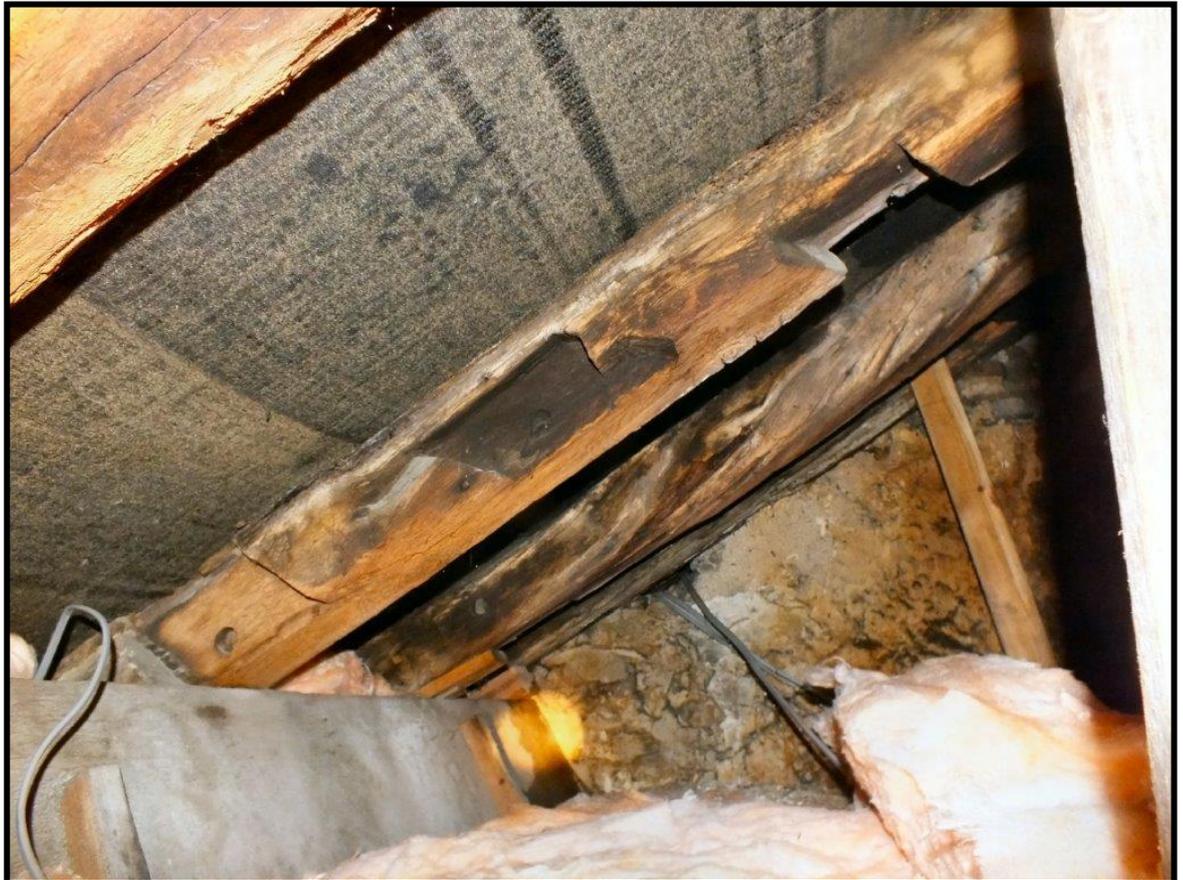
Image i/d KB 08 P08

Many of the rafters have redundant joints but one is particularly interesting as it has once had a collar brace attached by means of a notched lap joint. Both Alison Armstrong and Arnold Pacey felt this was likely to be early 13th century. They sent a photograph of the rafter, without information about the building, to Dave Stenning of Colchester an expert on medieval timber construction and he confirmed it had a 13th century notch lap joint. He suggested it may have been made for a scissor braced roof; these were often used at that time over stone walled structures.

Notched Lap Joint on Rafter

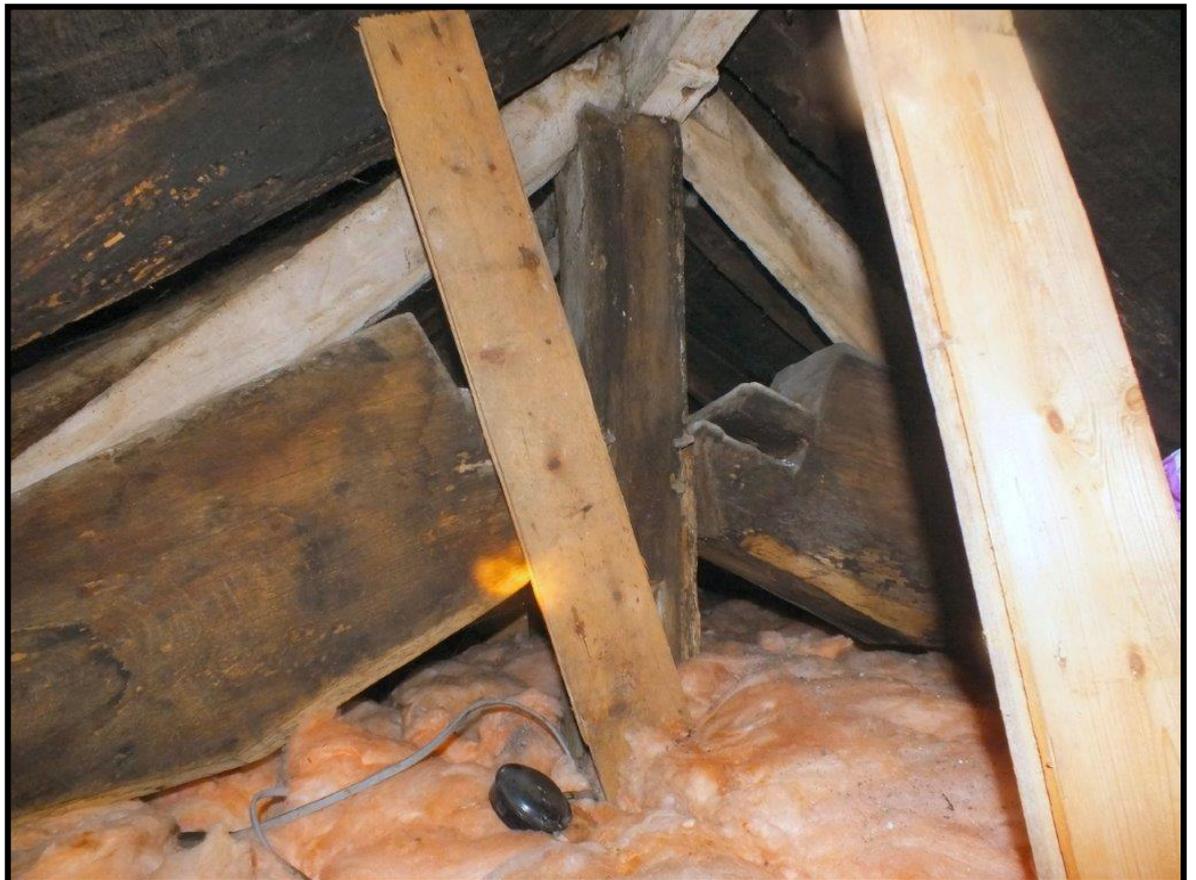
Image i/d KB 08 P12

Apex of West Truss

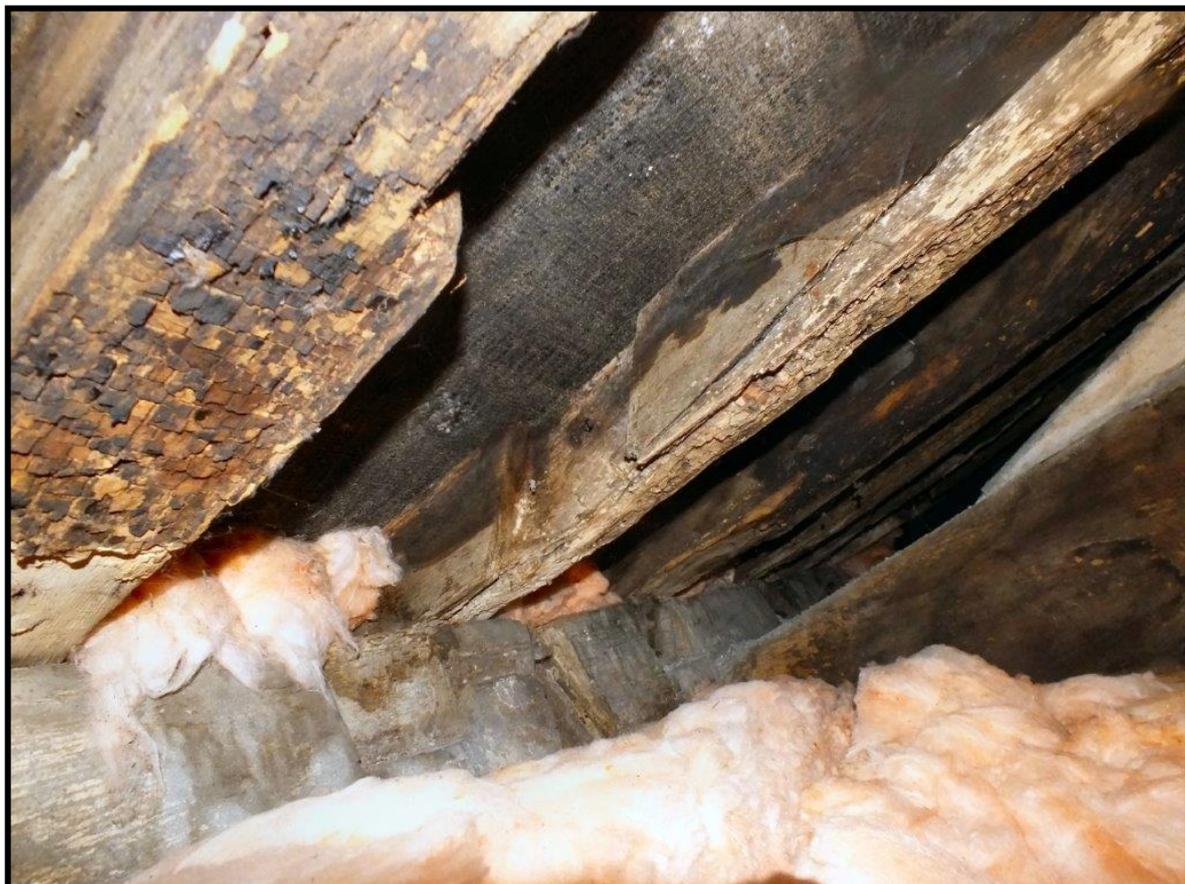
Image i/d KB 08 P13

Reused Wall Plate as Purlin
